Manhole Inspection Summary

Manhole # S23II_053MH

Location Address: **501 SANFORD PL**

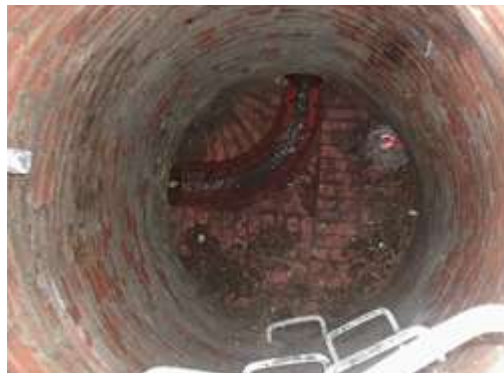
Top View

Evidence of surcharge - Bench debris.
Channel debris.

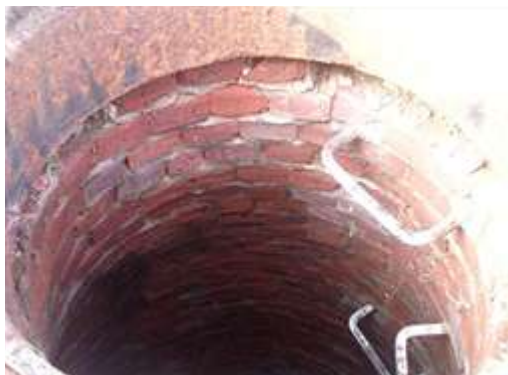
Defect

Frame leaks. Frame offset. Adjustment
and Corbel deterioration and infiltration.
Barrel infiltration - other side.

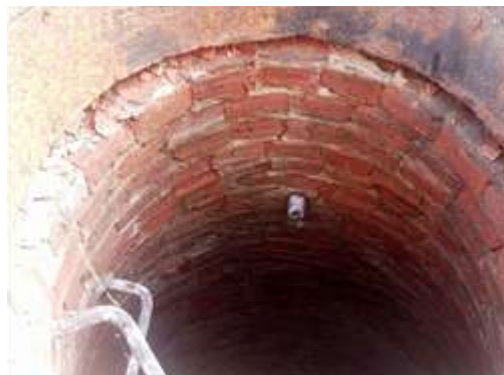
Defect

Frame leaks. Frame offset. Adjustment
and Corbel deterioration and infiltration.
Barrel infiltration.

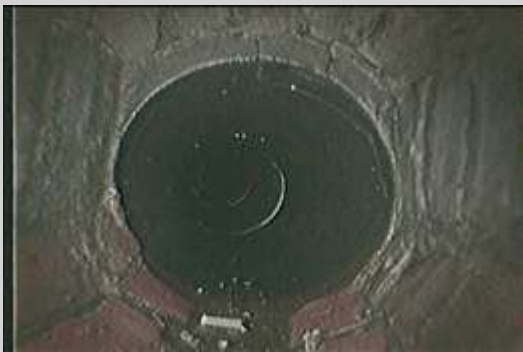
8 in. Circular Gravity Sewer Pipe Out @ 12 O'Clock

Infiltration: **None** Pipe Seal Cond: **Cracked**
